INSTRUMENT APPROACH CHART

RJKN / TOKUNOSHIMA

RNP Z RWY01

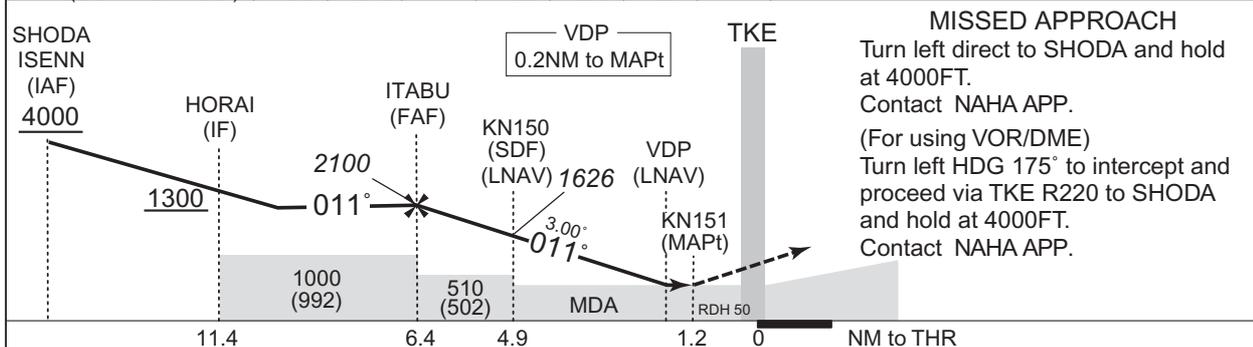
| NM to Next Fix | FAF | 5 | 4 | 3 | 2 | 1 | MAPt |
| ALT (3.0° APCH Path) | 2100 | 2040 | 1722 | 1403 | 1085 | 766 | - |
