| LOC I-SYA<br><b>110.1</b> | APCH CRS<br><b>287°</b> | Rwy Idg <b>10,004</b><br>TDZE <b>93</b><br>Arpt Elev <b>98</b> |

EARECKSON AS (SYA) (PASY)

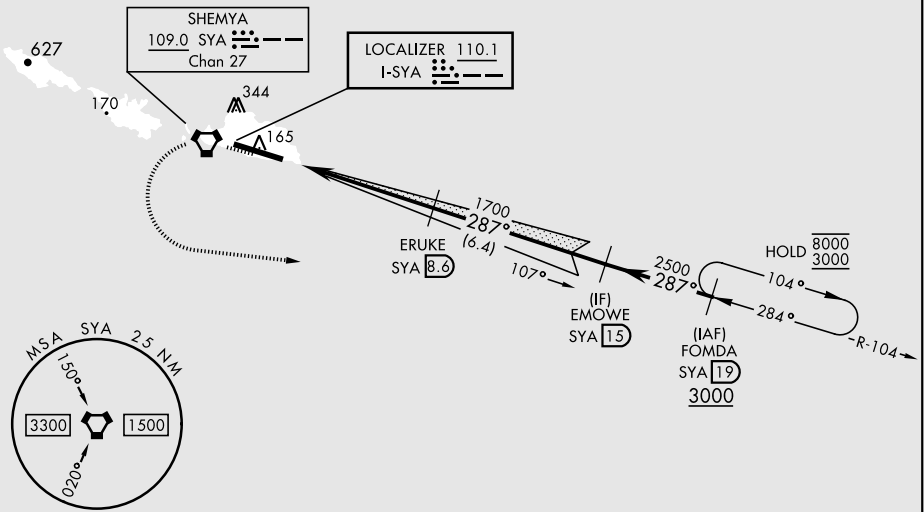
MISSED APPROACH: Climb to 600, then climbing left turn to 3000 direct FOMDA and hold.

CAUTION: Numerous obstructions in area N of Rwy 10-28.  
Missed approach requires use of RNAV or ATC RADAR monitoring.

VGSI and ILS glidepath not coincident (VGSI Angle 2.50/TCH 46).
